Subject: Engineering Information – Service Engine Soon Lamp Illuminated, Oil Leak Coming from Valve Rocker Arm Oil Control Valve, DTCs P0300, P3433, P3435 or P3409 Set

Brand:	Model:	Model Year:		VIN:		Engine:	Transmission:
		from	to	from	to		
Buick	LaCrosse	2017	2019	-	-	Equipped with 3.6L Engine (RPO LGX)	All
Cadillac	ATS	2016					
	CT6						
	CTS						
	XT5	2017				Equipped with 3.6L Engine (RPO LGX)	
Chevrolet	Camaro	2016					
	Colorado	2017				Equipped with 3.6L Engine (RPO LGZ)	
	Blazer	2019				Equipped with 3.6L Engine (RPO LGX)	
GMC	Acadia	2017					
	Canyon

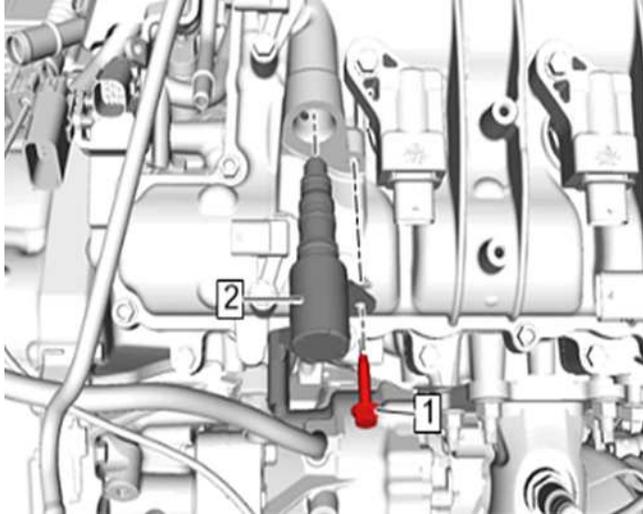
<p>Technicians may find oil leaking from the valve rocker arm oil control valve (2), as shown in the picture above, and/or one of the following DTCs set:</p> <ul style="list-style-type: none"> ● P0300: Engine Controls and Fuel ● P3433: Engine Controls and Fuel ● P3435: Engine Controls and Fuel ● P3409: Engine Controls and Fuel
<p>Cause</p>	<p>GM Engineering is attempting to determine the root cause of the above condition. Engineering has a need to gather information on vehicles PRIOR to repair that may exhibit this condition. As a result, this information will be used to "root cause" the customer's concern and develop/validate a field fix.</p>

1. Take a picture of the oil leak at the OCV location. A video is preferred so the engineer can determine the leak rate and leak location. If a video is not an option, a picture will be just fine.
2. Once it has been confirmed that the leak is coming from around the OCV, please send the pictures and/or video to the engineer noted below and call for further direction.
3. If engineer does not call back within the 2-hour requirement, it will be necessary to replace the camshaft cover without removing the OCV. Keeping the OCV intact without removing will be key to diagnosing this concern.
